Home Inspection Report

2002 Sample St.
Anytown, TX

PROPERTY INSPECTION REPORT

By: Ted Kruger / TREC # 5209 10/25/2004
(Name and License Number of Inspector) (Date)

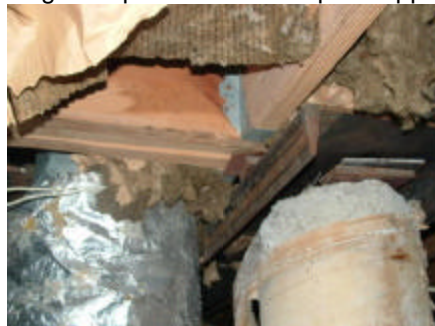
Solid concrete piers with solid concrete bases are present for proper vertical support of wood floor joist and wood beams – all woodwork appears to be in average condition and appears to be properly supported as intended with exception of one concrete pier at the front of house under porch area – this pier is not properly positioned under the wood triple 2" x 12" beams as designed – currently the triple beam is only being supported by one of triple beams – it is suggested to properly position this pier under the entire beam as designed for future performance.

Extensive foundation repairs have been installed as viewed from under house today – several steel "I" beams have been installed at the middle of foundation to assist in long term performance – repairs appear to be satisfactorily completed – FYI.

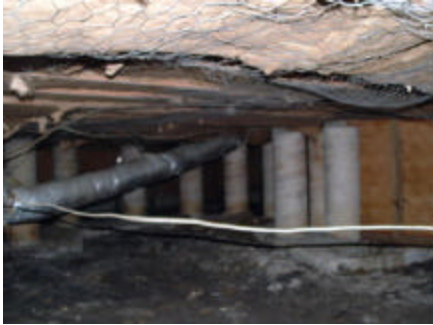
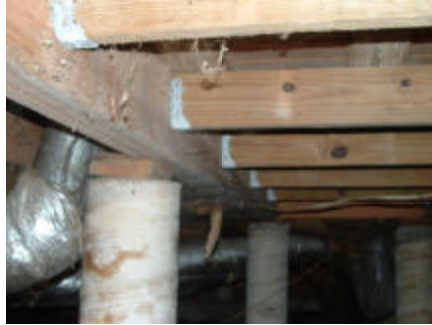
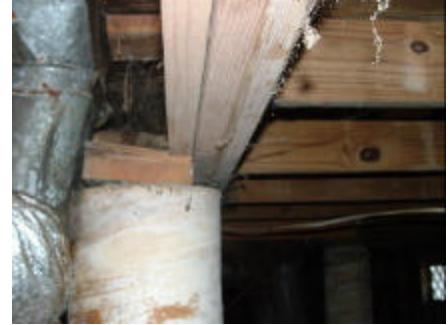
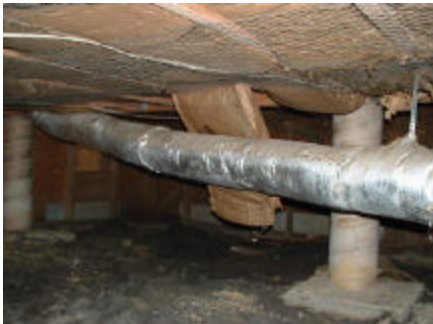
The insulation present under floor decking is in average condition, however several loose batt insulations sections are present and no insulation is present at area that has been improved with steel beams – FYI.

It is my opinion that the pier and beam foundation is performing its intended function at the time of inspection – no evidence of foundation failure was observed, however minor adjustments are needed at the pier to beam connection at the front porch area as described above – FYI.

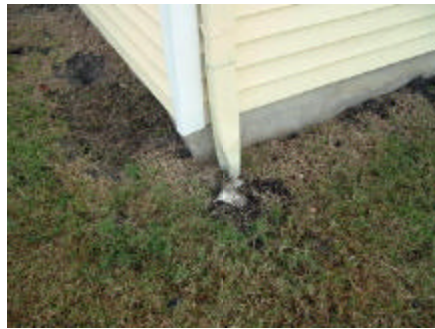
Negative grading and drainage slope is present at the front and rear of foundation – currently this issue is being corrected to prevent water from transferring under foundation – FYI.

Install gutter downspout tail piece at the left front of garage as needed to prevent excessive amounts of water from being deposited at the edge of foundation.

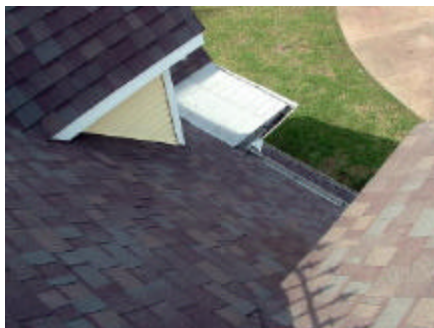
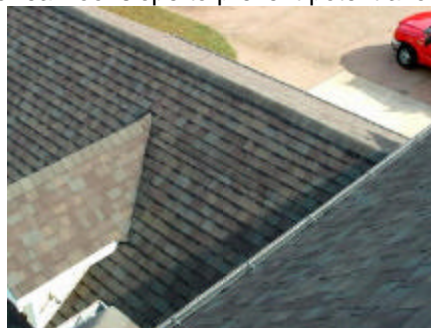
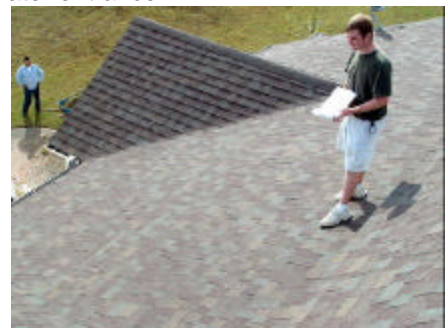
The fiberglass composition shingle roof appears to be in good condition, all roof flashings and vent stacks have been properly installed, proper attic ventilation is present and no signs of water entrance were observed today – nice features – it is suggested to completely seal the entrance of cable for dish mounted on roofing at the rear roof slope to prevent potential of water entrance - FYI.

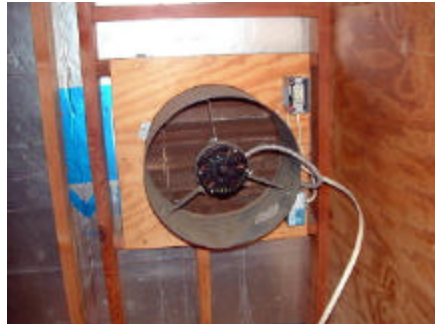
The attic fan at the right side does not have fan blades installed and no power is present to device – repair as needed.

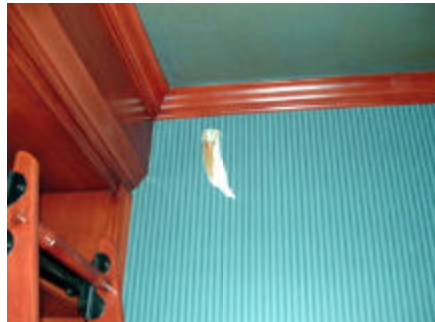
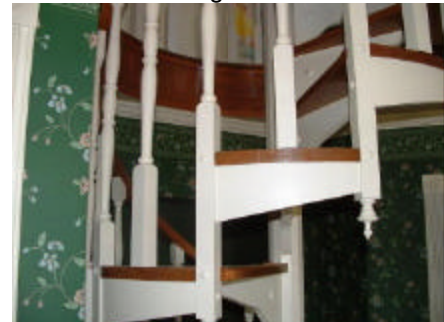
Minor sheetrock damage is present at the right side at front formal den – cosmetic. The handrail at the stairway area does not transfer completely in stairway as required by today's TREC standards – FYI.

The spacing between the stair rail spindles is greater than the 4" maximum allowed by today's TREC standards – child safety issue.

Repair the sheetrock cut-outs at the electric panel located in garage as needed.

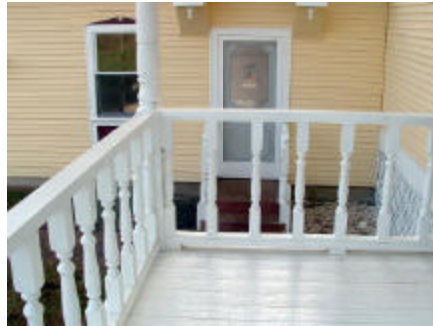
Vinyl siding and aluminum fascia has been installed – product appears to be properly installed and is in average condition, however one siding section at the right side at porch area is short to cover as intended – repair as needed. The spacing between the rail spindles at front porch and 2-story balcony area is greater than the 4” maximum allowed by today’s TREC standards – child safety issue.

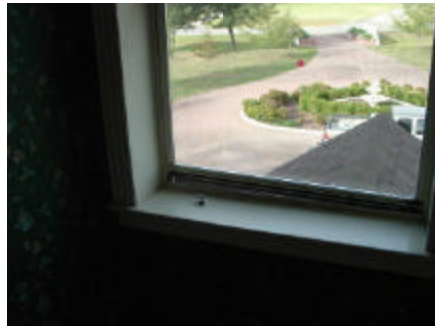
Numerous windows do not open as intended – windows appear to be painted shut – FYI.

Several windows have defective lock devices, windows out of square windows present that do not close properly and one glass pane in garage is cracked and should be replaced as needed – repair all defective windows and locks and attempt to cut paint and caulk present at windows that do not open in all bedrooms for secondary fire escape route – FYI.

The stain glass windows at the stairway landing area could not be verified to be tempered glass as required by todays TREC standards – FYI.

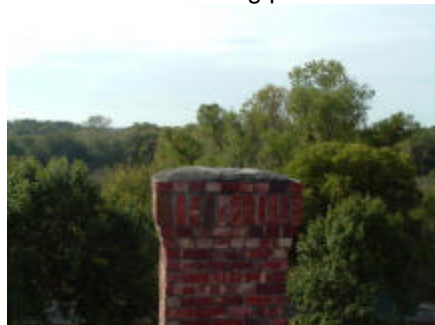
The fireplace unit at the right side of house is properly installed and vented as needed, however it is suggested to install a full coverage type chimney cap at the top of chimney to prevent water entrance into flu liner – FYI.

The front fireplace unit has been blocked at the flu area – this unit should not be used for wood burning products – FYI.

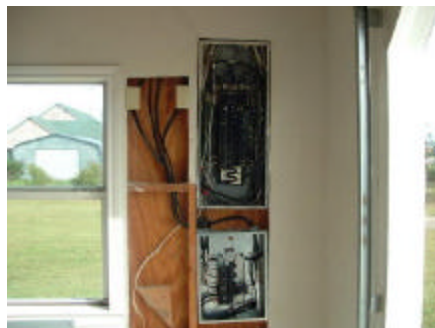
A newer electrical and sub panel have been installed – no significant issues observed in main or sub panel other than miss matched wire to breaker sizes at the bottom 30 amp. breaker that is connected to 12 ga. wire (should be 10 ga. wire on 30 amp. breaker) – no evidence of overloading or burned wiring was observed today – FYI.

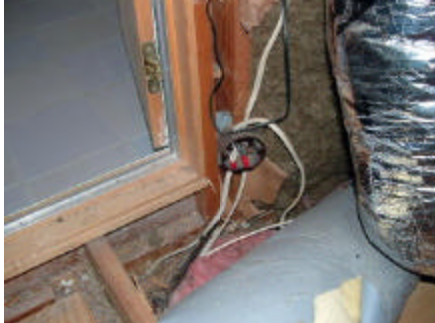
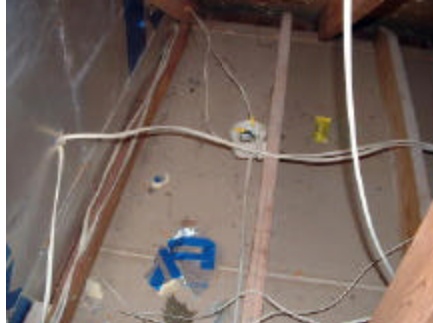
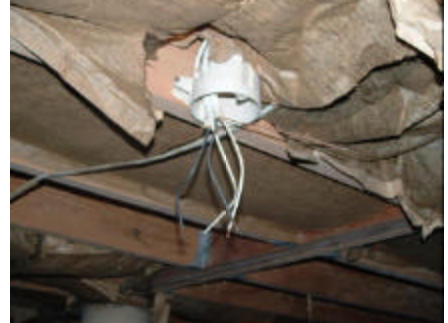
Several outlets in upstairs left rear bedroom area have hot and neutral reversed – repair as needed – red dots.

Decking has been installed over romex wiring in attic at the 3rd level attic area – safety concern – FYI.

Several outlets do not have covers present and there is “J” box in attic over garage area that does not have cover present as well – repair as needed.

Several circuits under the front section of house in “J” box are not properly terminated or tied to fixture as intended – repair as needed.

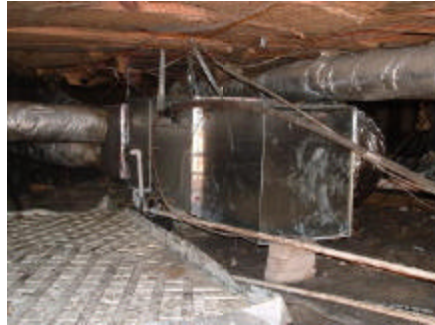
The downstairs electric heat unit appears to be newer unit and the upstairs unit appears to be older electric unit – both units functioned properly today producing 112-degree air during testing - FYI.

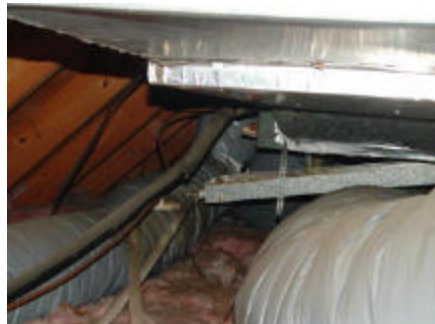
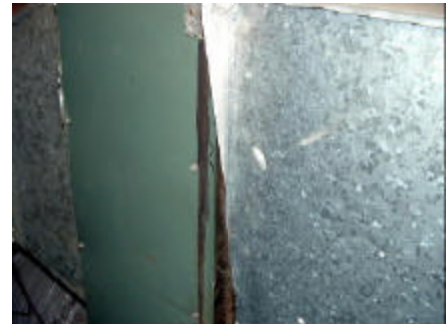
Comments: UPSTAIRS UNIT – Older exterior condenser unit and coil in attic – FYI. The supply vent is cooling at 51 degrees and the return vent temperature is 71 degrees with a temperature differential of 20 degrees. The unit is cooling within acceptable tolerances at this time, however loose tape seams are at the front of coil resulting in air loss into attic and there is no primary condensate drain line present at coil to deposit condensate water into “P” trap as required by todays TREC standards – currently water from coil deposits into metal emergency drain pan and is routed into PVC below house – FYI.

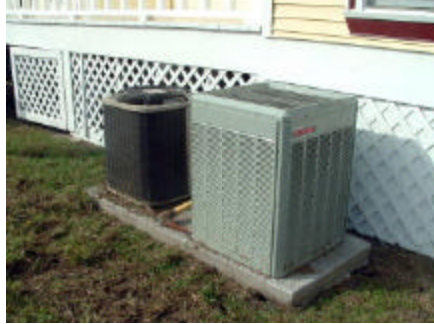
DOWNSTAIRS UNIT - Newer exterior condenser unit and coil under house – FYI. The supply vent is cooling at 60 degrees and the return vent temperature is 73 degrees with a temperature differential of 13 degrees. The unit is NOT cooling within acceptable tolerances at this time. It is suggested to contact licensed HVAC contractor for further evaluation of issues listed above and repair as needed.

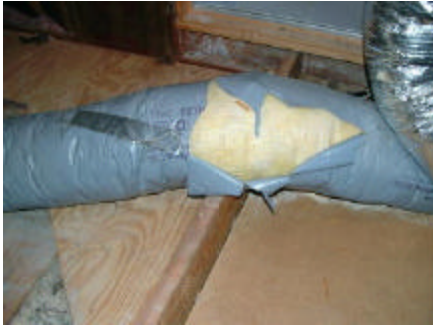
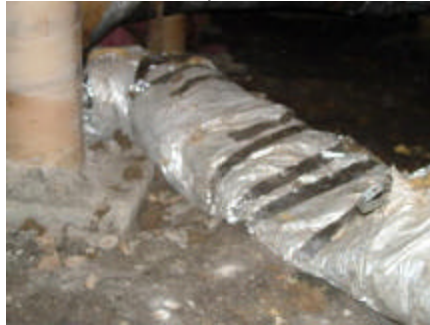
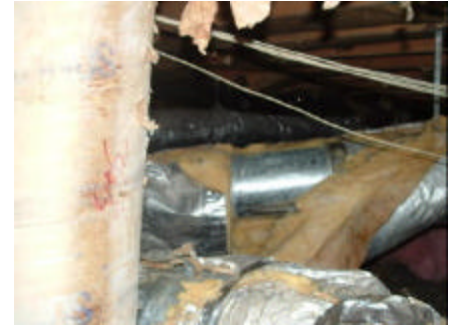
Several damaged vinyl faced flex ducts are present in 3rd level attic area and several metal ducts under house are damaged and elongated – this issue may allow poor air distribution to supply registers for downstairs area – damage appears to be from workers under house – FYI.

20" x 25" – downstairs wall mounted – it is suggested to properly seal the return air chase as needed to prevent future filtration issues - FYI.

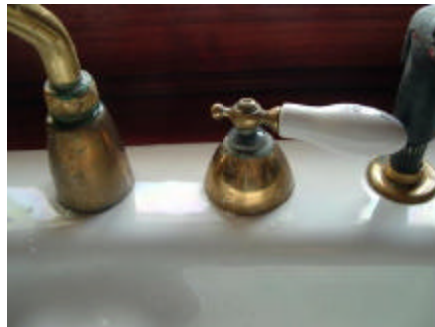
All plumbing related water devices functioned properly at the time of inspection, however minor water leaks were observed at the cold water valve stem at kitchen sink area as well as at the washer box connections during testing - FYI.

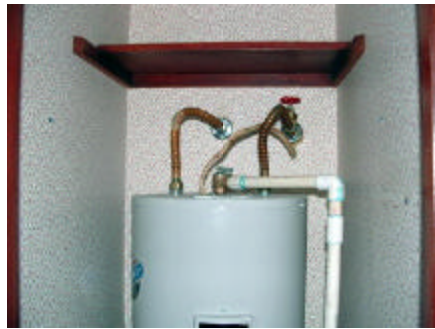
A newer unit has been recently installed – unit functioned properly today during testing, however by todays TREC standards the T & P drain line should be 3/4" copper and terminate to an exterior wall, exposed romex wiring at the top of unit should be routed in conduit and an electrical disconnect should be present – FYI.

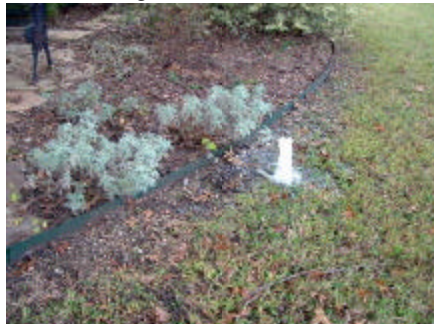
<i>Comments:</i>
The sprinkler system is operated in the manual mode only from control box located in garage.
There are 3 controllers present in garage area – Box A did not respond to demand for water at all today during testing of system and Boxes B and C did activate during testing emitting water on several zones (several damaged heads observed) , however majority of zones did not function during testing.
Due to numerous issues observed with all control boxes it is suggested to contact a licensed irrigator for further evaluation and repairs as needed. |

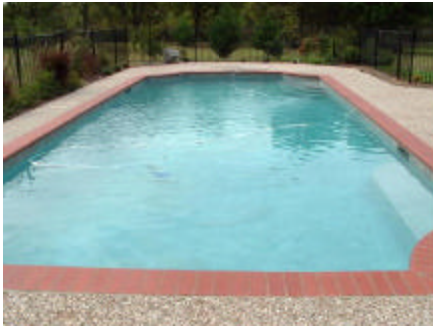
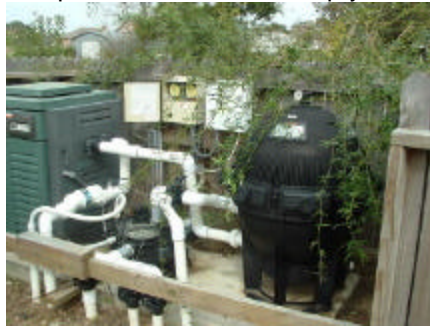
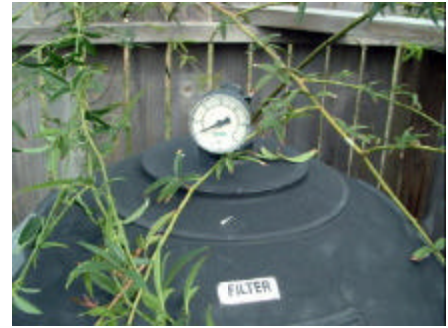
The home has a gunite pool present and appears to be properly installed and is in average condition – overall good water movement was observed during testing, no leaks were observed on visible pool supply lines, pool light functioned properly and is GFCI protected as needed.

Filter unit has appropriate head pressure, however the pressure gauge is defective and should be replaced as needed and pool pump motors are properly grounded as needed – freeze protection is present for pump motors - FYI.

Pool Polaris unit functioned properly today – propane heater unit was tested and auto ignite feature attempted to ignite gas during testing, however no flame was produced – it appears that the propane tank is empty – FYI.
