# Home Inspection Report

## **PROPERTY INSPECTION REPORT**

**Concerning:** 2001 Sample St.  
(Address or Other Identification of Inspected Property)

**By:** Ted Kruger / TREC # 5209 10/26/2004  
(Name and License Number of Inspector) (Date)

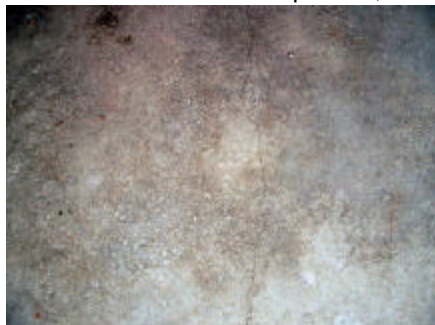
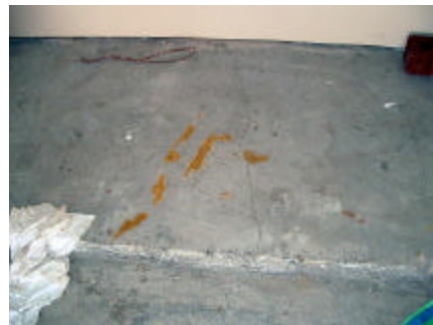
Minor hairline surface fractures are present in garage foundation which is typical of most foundations due to normal curing and settling of foundation – due to size and location of minor hairline surface fractures they are considered to be typical and cosmetic – not structurally related in my opinion.

The post tension reinforced foundation appears to be performing its intended function at the time of inspection, no evidence of foundation failure was observed.

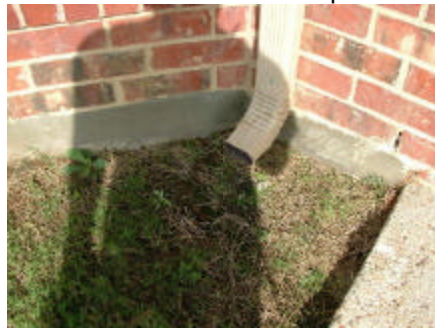
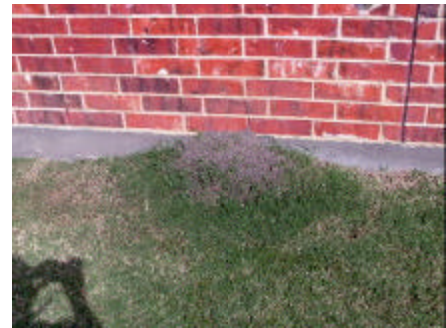
Proper grading and drainage was observed at the time of inspection, however concrete collection boxes should be installed at the bottom of all gutter downspouts to prevent washout of soils – FYI.

Several large ant mounds were observed at the edge of foundation and appear to be gaining access into wall cavity at the weep holes – it is suggested to properly treat all areas as needed to prevent this issue.

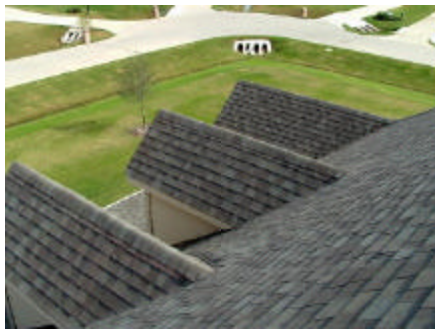
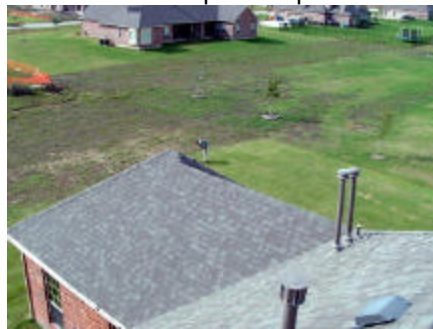
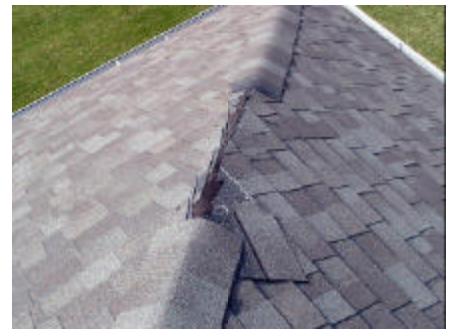
The fiberglass composition shingle roof appears to be in good condition, all roof flashings and vent stacks have been properly installed, proper attic ventilation is present and no signs of water entrance were observed today, however several wind damaged and missing hip/ridge shingles are present at the right rear of roof area – install as needed to prevent potential of water entrance.

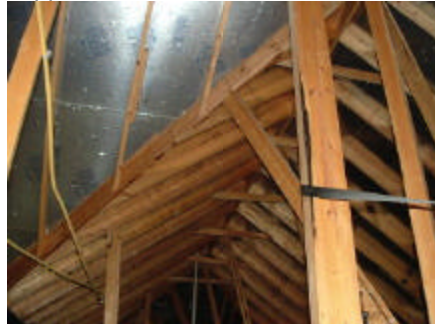
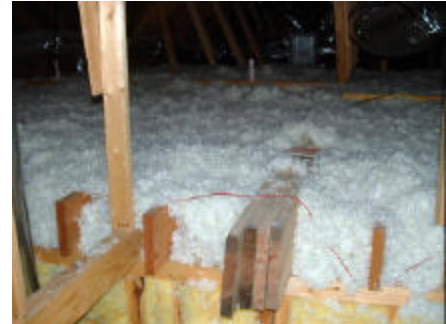
Above average attic insulation, solar ply roof decking present and good vertical roof supports observed as well – nice features.

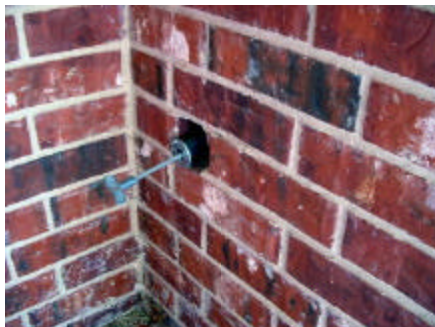
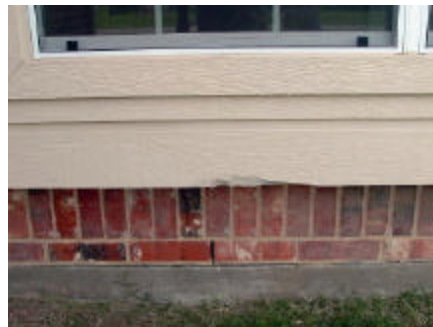
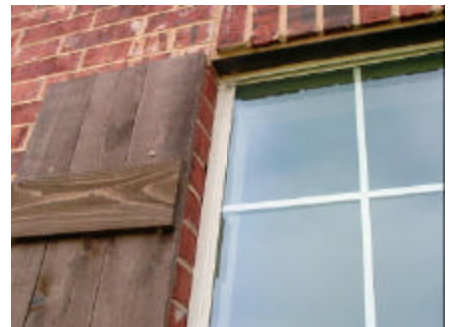
Repair the damaged bricks at the rear patio area at the side of fireplace unit at gas valve as needed.

Replace the damaged siding at the left side of house at bottom course of window – paint as needed.

Properly caulk the window frame to brick at the front of house as intended to prevent water / vermin entrance.

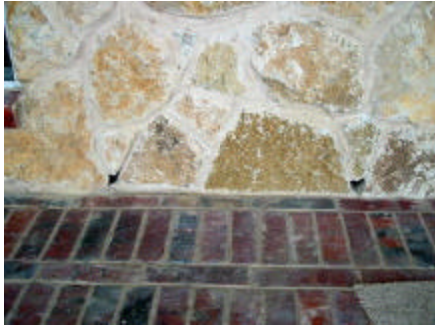
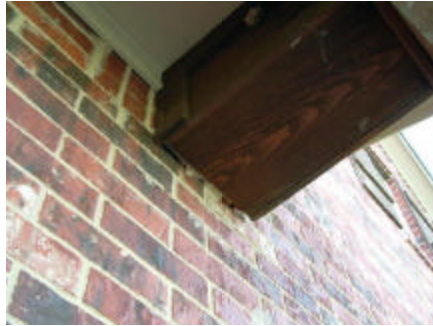
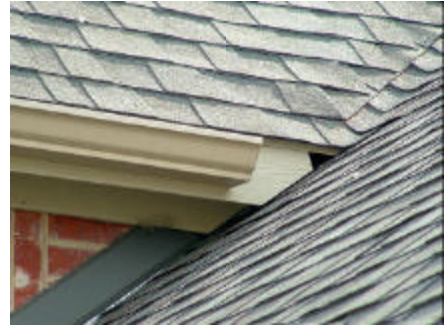
Several weep holes at the front porch stone façade wall are extremely large – it is suggested to reduce size of weep hole to prevent potential of vermin entrance. Properly seal the void present at the front porch beam header to brick to cover exposed woodwork present. Repair the damaged fascia at the right of front entry at roofline – paint as needed.

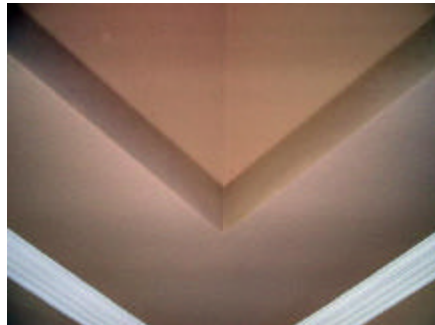
Minor hairline sheetrock fractures are present at the transition area of slope ceiling in master bedroom - this issue is considered to be typical and cosmetic due to size and location (most homes with this type of ceiling configuration will experience this minor type of sheetrock fracture) – not structurally related – FYI. Hardwood floor was found to have minor cupping of wood planks – it is suggested to sand smooth and finish as needed - cosmetic.

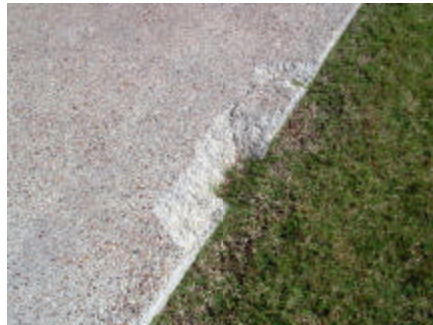
Properly repair the damaged exposed rock flatwork at the rear patio area as needed.

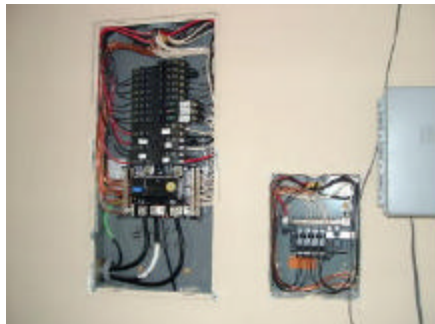
No issues observed in main panel or sub-panel located in garage – main disconnect present and proper wire to breaker sizes were observed; nice wiring job, however one breaker for left side bedroom and master bedroom outlets is tripped and will not reset – FYI.

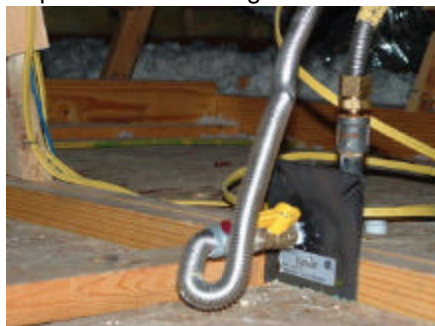
Both gas fired auto ignite furnaces appears to be properly installed and vented as needed – units functioned properly today, however a significant gas leak was detected at the cut-off valve for right side furnace in attic over garage – red dot – Inspector has turned gas valve off as a precautionary measure - FYI.

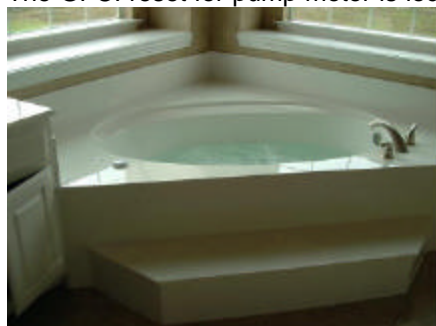
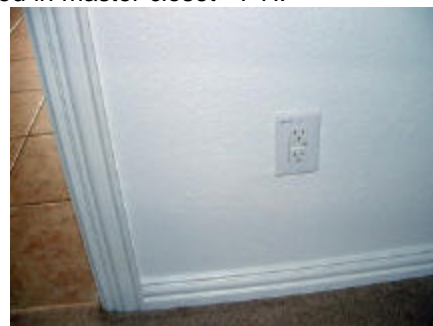
Unit functioned properly today, however by today's TREC standards a readily accessible service access panel is required to be present on tub unit, Inspector could not verify proper grounding of pump motor or check for leaks at the time of inspection – consideration should be given towards installing access panel at the side of cabinet - FYI.

The GFCI reset for pump motor is located in master closet - FYI.

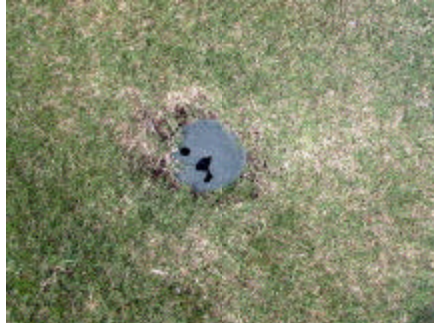
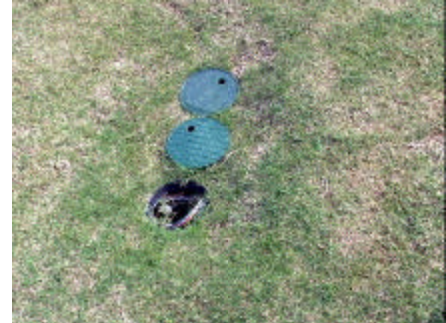
One valve zone box at the front yard area emits an electrical noise and coverlid is not installed.

One valve zone box at the rear of game room area has a damaged coverlid present.

Zone # 4 – several heads water street – adjust as needed.

Zone # 7 - several heads water street – adjust as needed.

Zone # 13 – Several heads at the rear of house water exterior brick façade wall – adjust as needed.

Zone # 14 – one head at the rear of house does not pop up over grass line resulting in poor coverage.
