Home Inspection Report

PROPERTY INSPECTION REPORT

Concerning: 2003 Sample St.
(Address or Other Identification of Inspected Property)

By: Ted Kruger / TREC # 5209 09/20/2004
(Name and License Number of Inspector) (Date)

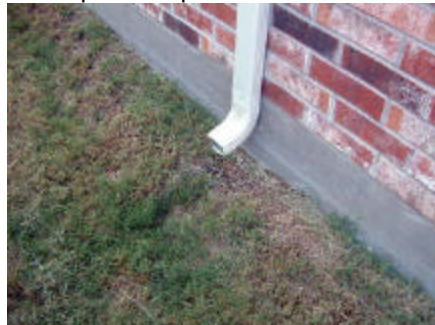
Proper grading and drainage was observed at the time of inspection, however it is suggested to install concrete drainage collection boxes at the bottom of all gutter downspouts to prevent washout - FYI.

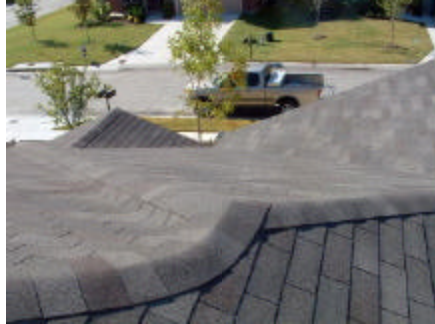
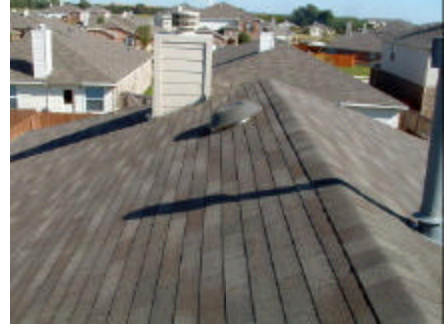
The fiberglass composition shingle roof appears to be in good condition, all roof flashings and vent stacks have been properly installed, proper attic ventilation is present and no signs of water entrance were observed today – nice features.

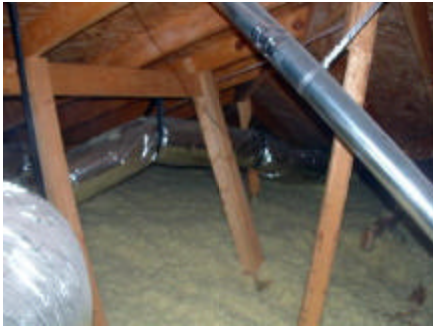
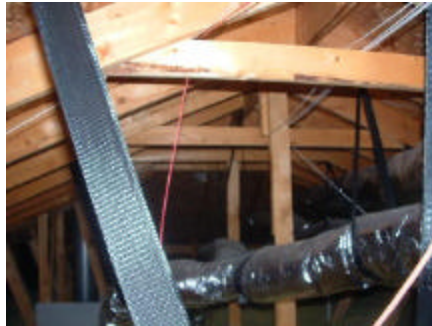
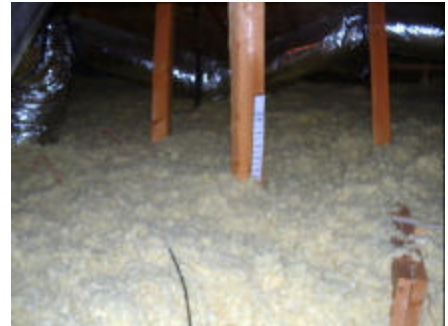
Above average attic insulation present and good vertical roof supports observed as well – nice features.

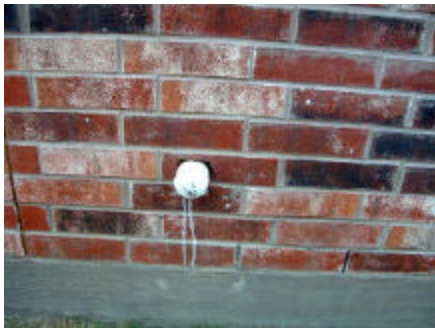
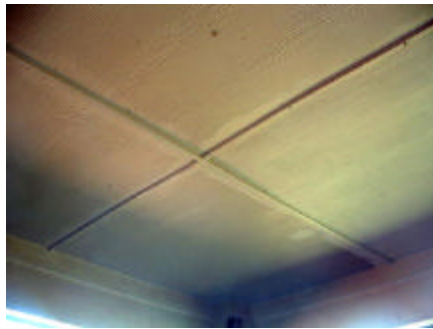
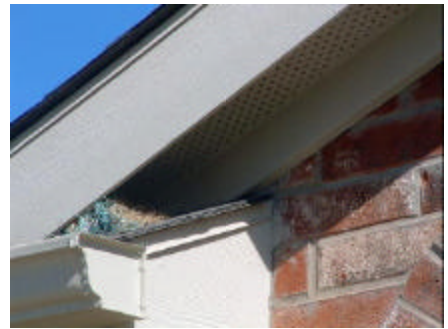
No significant issues observed on exterior brick façade walls or exterior trims – good job of weatherproofing the exterior of house, however the voids at the right side of house at the PVC clean out should be completely sealed as needed and paint touch-up improvements are needed at the rear patio at soffitt and new screen mold trim installed.

Remove the bird nest at the front gable area under soffitt at the roof return and seal all excessive voids at this and all similar locations as needed to prevent potential of water or vermin entrance.

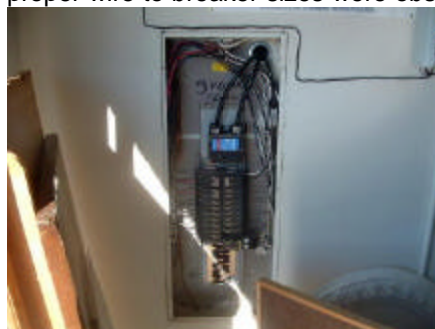
No issues observed in main panel located in garage – main disconnect present and proper wire to breaker sizes were observed; nice wiring job – FYI.

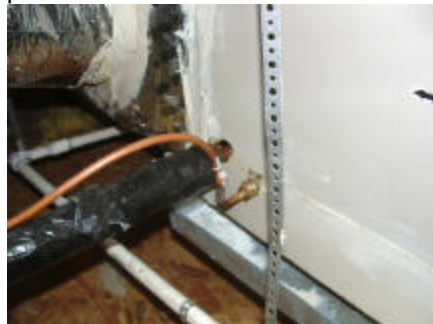
Inspection of corrosion/damage at the enclosed evaporator area of the air conditioning system is not included as part of this non-invasive visual inspection. In order to determine the performance of the air conditioner, average temperatures are taken from the supply and return vents of the system. Anything between a 15 and 22 degree differential is considered to be acceptable.
 <i>Type And Energy Source:</i>
 <input checked="" type="checkbox"/> Conventional / Forced Central Air <input type="checkbox"/> Window Unit <input type="checkbox"/> Geo-Thermal
 <input checked="" type="checkbox"/> Electric / Number of units 1 / Exterior temperature 85 degrees
 Service disconnect present <input checked="" type="checkbox"/> Yes <input type="checkbox"/> No
 <i>Comments:</i>
 The supply vent is cooling at 52 degrees and the return vent temperature is 72 degrees with a temperature differential of 20 degrees. The unit is cooling within acceptable tolerances at this time, however the void present at the coil on unit in attic where copper suction lines enter should be properly sealed as needed to prevent excessive air loss into attic and maximize efficiency of unit.</p> |

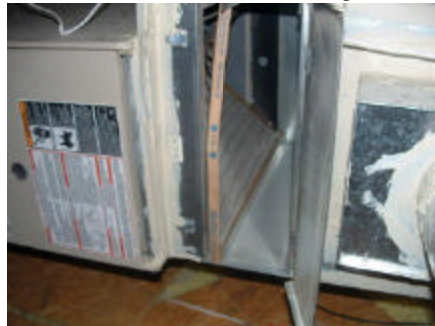
20" x 25" – located at the return air side of unit in attic – currently filter is dirty and has been sucked into fan blower area (this issue can result in poor performance of unit – FYI) – replace as needed – consider installing 4" type media filter for extended time between changes – FYI.

The HVAC filter should be replaced upon moving in and regularly.
