Home Inspection Report

2006 Sample St.
Anytown, TX

PROPERTY INSPECTION REPORT

Concerning: 2006 Sample St.
(Address or Other Identification of Inspected Property)

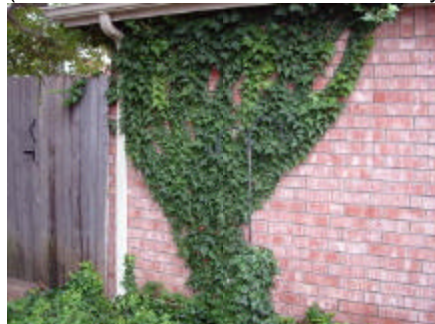
It is suggested to control the ivy ground cover present at the left side of foundation (conductive condition for wood destroying insects and water entrance).

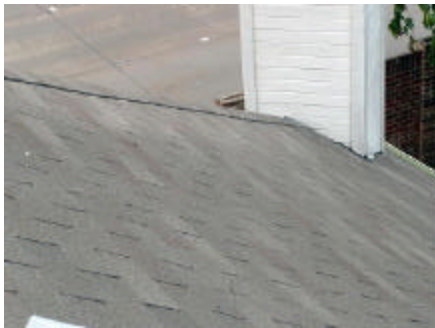
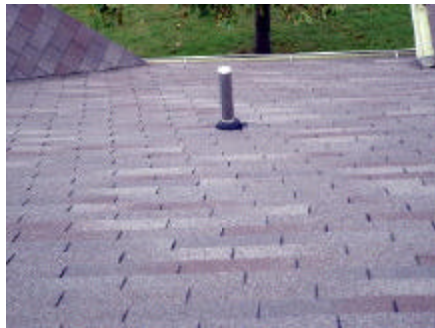
The fiberglass composition shingle roof appears to be in average condition, all roof flashings and vent stacks have been properly installed, proper attic ventilation is present and no signs of water entrance were observed today – nice features. It is suggested to clean all debris out of rain gutter over the front entry area as needed – FYI.

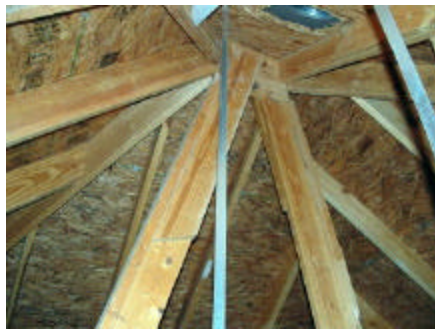
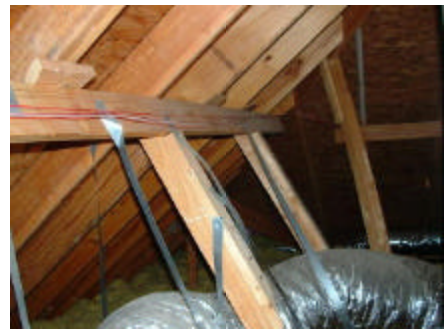
Above average attic insulation present and good vertical roof supports observed as well – nice features.

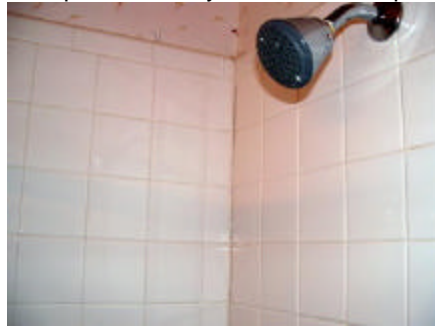
No significant issues observed at interior sheetrock walls and wood trims, however it is suggested to completely caulk the inside corner grout voids at the master shower as a precautionary measure from potential of water entrance – FYI.

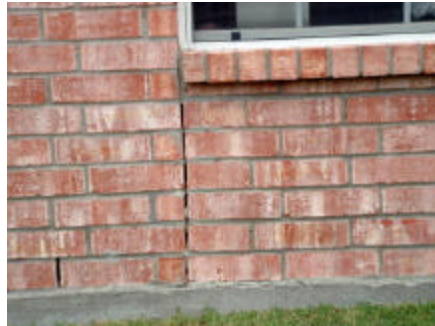
No issues observed on exterior brick façade walls or exterior trims – good job of weatherproofing the exterior of house, however the brick expansion joint at the right side of house below window should be properly sealed as needed – FYI.

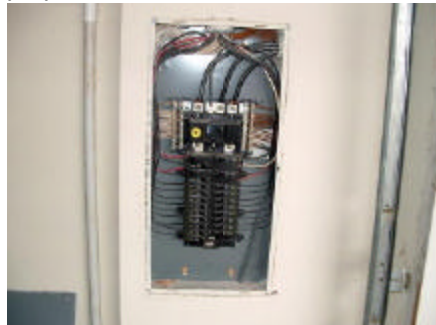
No issues observed in main panel located in garage – main disconnect present and proper wire to breaker sizes were observed; nice wiring job – FYI.

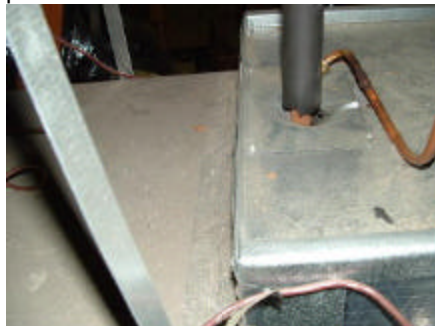
The supply vent is cooling at 53 degrees and the return vent temperature is 70 degrees with a temperature differential of 17 degrees. The unit is cooling within acceptable tolerances at this time, however the void present at the coil on unit in attic where copper suction lines enter should be properly sealed as needed to prevent excessive air loss into attic and maximize efficiency of unit.

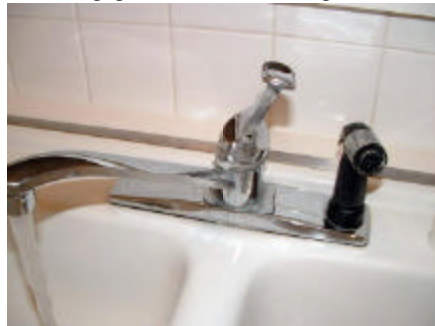
All plumbing related water devices functioned properly at the time of inspection, however a significant water leak was observed at the base of kitchen faucet resulting gin water collecting at the top of sink area – repair as needed.

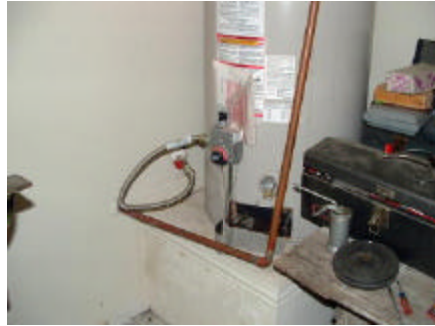
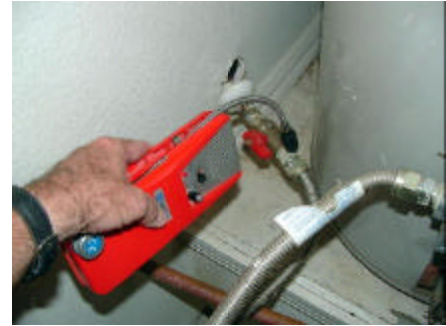
Unit functioned properly today and is vented as needed, however a significant gas leak was detected at the cut-off valve at flex gas supply line – Inspector has turned gas valve off to unit as a precautionary measure – repair gas leak as needed and re-light pilot light for hot water heater.
