# Home Inspection Report

**2000 Sample St.**  
**Anytown, TX**

## **PROPERTY INSPECTION REPORT**

**By:** Ted Kruger / TREC # 5209 10/18/2004  
(Name and License Number of Inspector) (Date)

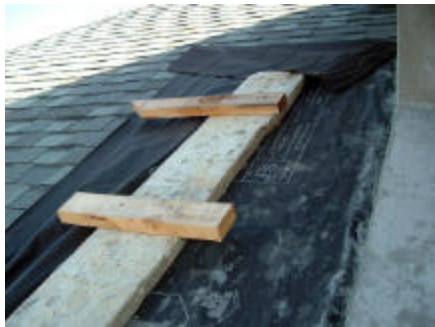
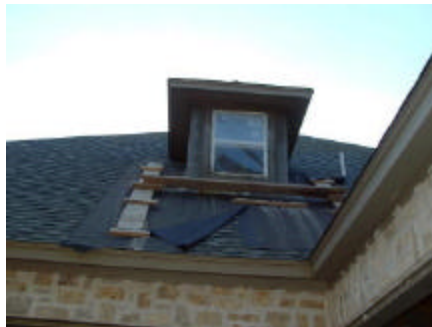
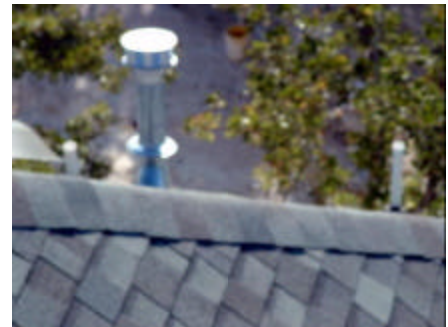
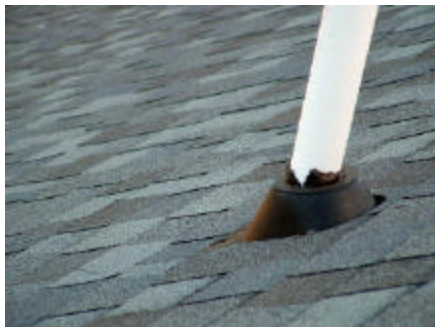
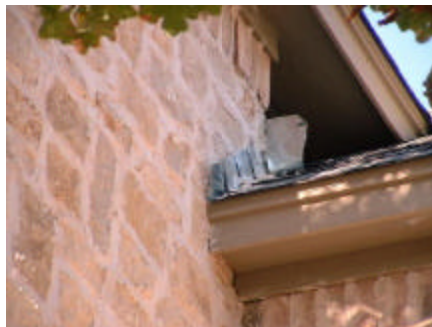
Power ventilators present – consider wind turbine for long term performance  
Properly repair or seal all holes in shingles where toe boards were present at stucco areas.  
Lower the rain collar vent flashing at left side of roof to prevent potential of water entrance.  
Several PVC flashing boots damaged at rubber gasket right side of roof – replace as needed.  
Install counter flashing shingles at the front left of house at 2-story area as needed to prevent water entrance.  
Overall the fiberglass composition shingle roof is in good condition – no significant issues observed – FYI.

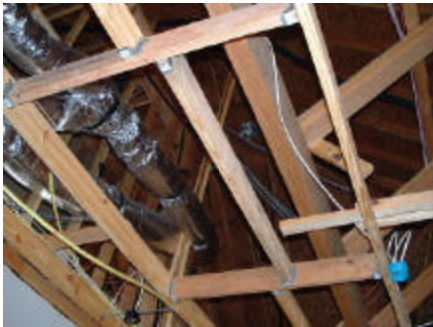
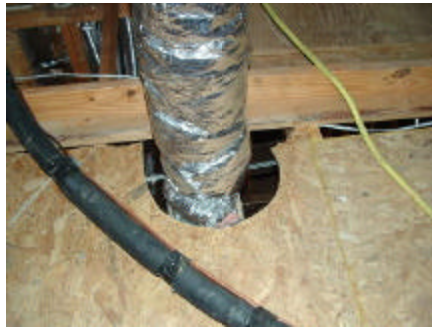
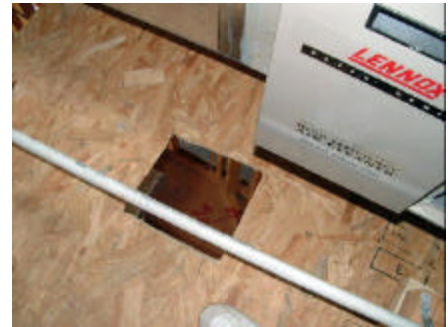
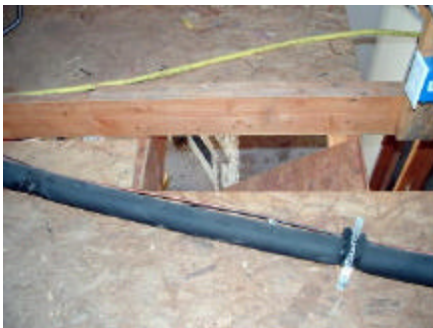
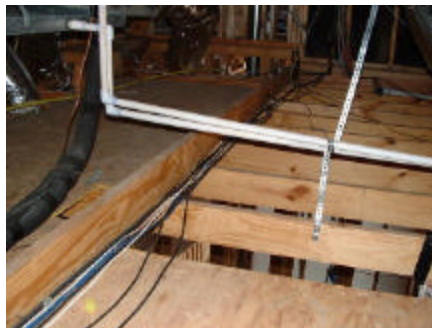
**D. Roof Structure & Attic** (If the attic is inaccessible, report the method used to inspect.)

Install platform decking at top of pull down stairs at single car garage to front of units as required by TREC standards.

Replace damaged OSB at front of unit in attic off of garage area and properly support existing OSB at front of unit & cut out areas – currently several areas are weak and are considered to be hazards when stepped on improperly.

Suggest install decking in attic beyond strong back at attic area in front of units. Decking improvements needed at 3<sup>rd</sup> floor attic area near horizontal units – safety concern.

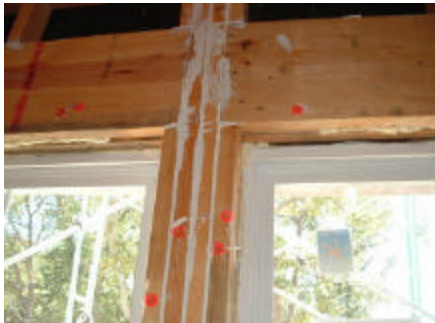
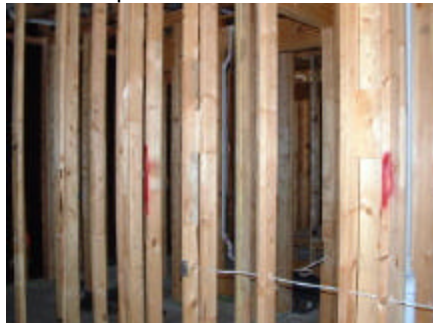
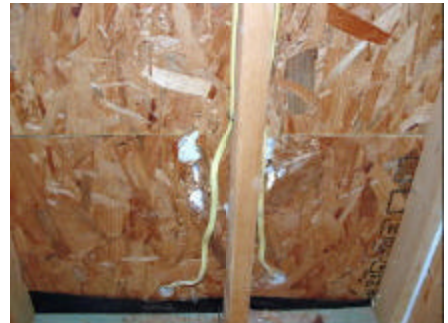
**DS FRONT ENTRY OFFICE**

Several bowed studs present.

Repair damaged OSB front exterior wall.

Foam seal improvements at windows and inside corners of studs.

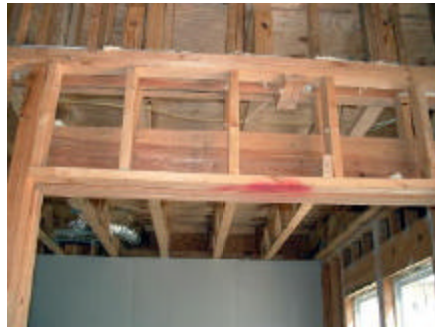
**DINING ROOM**

Level 2x4 furr down flush with header at entry area  
Foam seal improvements at windows and inside corners of studs  
Bowed stud

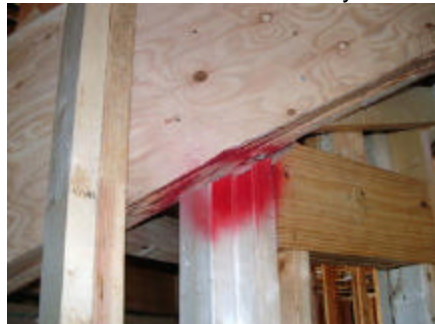
**FRONT ENTRY & SMALL HALLWAYS**

Improvements needed at top of studs under radius stairwell for vertical support  
(significant void)  
Bowed stud – left side hallway

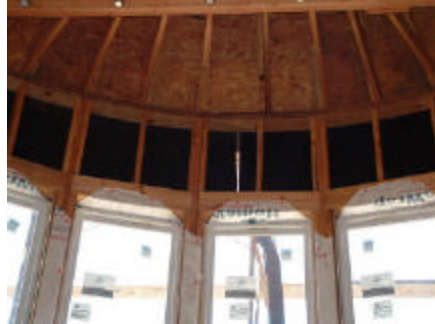
**DS SMALL DEN**

Remove nails & studs (sheetrock obstructions)  
Add bottom plate piece rear exterior wall – 2 areas  
Foam seal improvements needed at windows  
No foam seal on upper windows  
Significant voids at exterior blackboard above upper windows and below lower windows

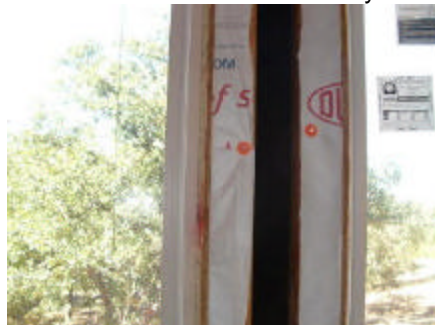
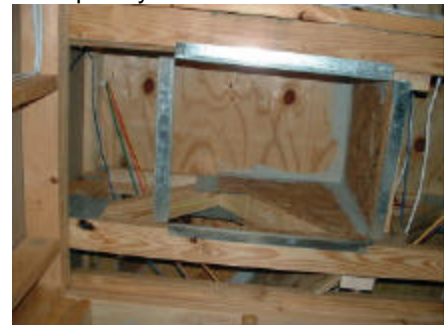
**MASTER BEDROOM**

Foam seal improvements needed at windows and inside corners of studs  
Poor reveal at numerous windows at window frame to sheetrock  
Several bowed studs present  
Header not flush with cripple at entry door area  
Return air duct chase over entry door not completely sealed at inside area

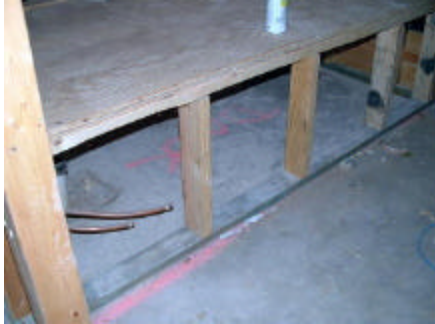
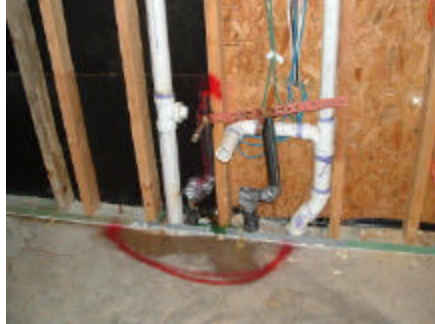
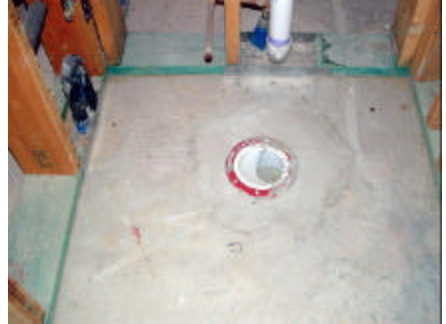
**MASTER BATH**

Tub deck to be altered in size (per Bob) – verify access panel to be installed at front or side of tub unit as required.

Water leak at supply line left side exterior wall – due to leakage present it is suggested to re-test supply lines after repair for additional leaks – FYI.

Several bowed studs present

Protect all vinyl liner shower pans and toilet drains as needed

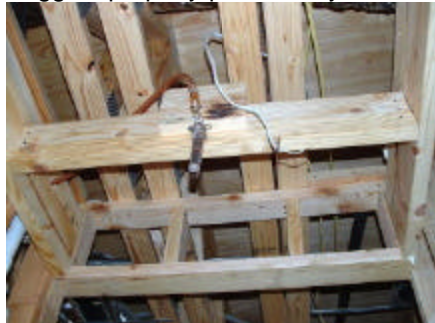
Headers not flush with cripple at entry door

Properly terminate 14 gauge wire at top of master shower

Nail 2"x4" to 2"x6" in toilet area

Suggest install deadwood for toilet rollers, towel bars, etc...

Master Closet - Properly Fur out exterior wall at AC lines (not flush)

Repair damaged blackboard left side exterior & OSB

Properly caulk/foam seal excessive voids at all wall intersections

Install deadwood top of wall left side toilet

Suggest properly protect vinyl liner at master shower area

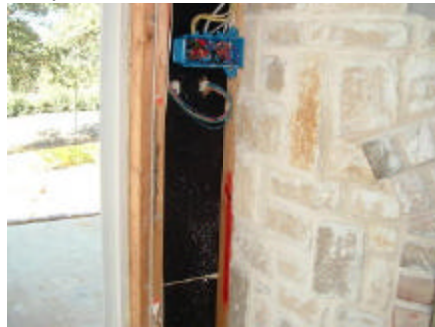
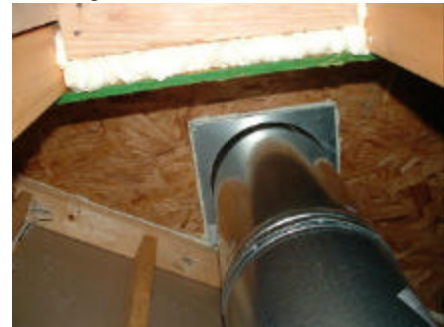
KITCHEN/REAR LIVING ROOM

Fur out 2"x6"s by refrigerator area  
Foam seal improvements needed at windows, doors & inside corners of woodwork – numerous areas  
Install deadwood at exterior wall side of fireplace  
Doors to garages not installed  
Fireplace – Foam seal flu at furr down & install gas bar as needed.

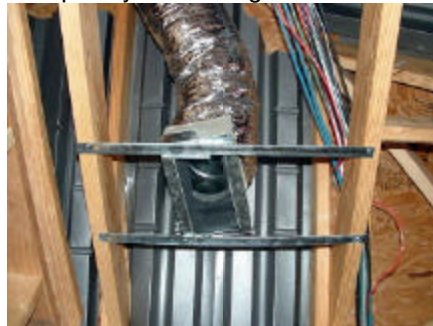
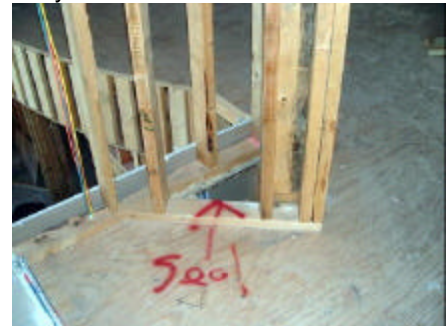
**SECOND FLOOR LEFT REAR BEDROOM**

Properly straighten and secure metal register in room & closet  
Several bowed studs present  
Completely seal triangular return air chase by door area

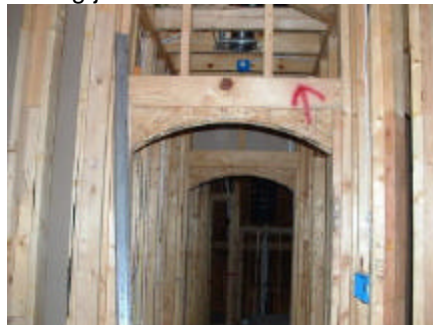
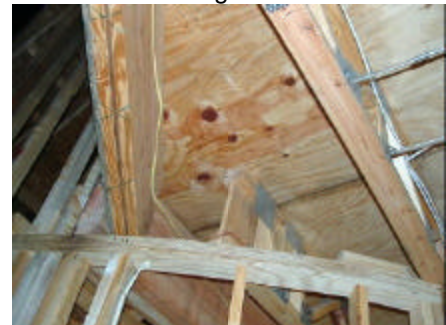
**SECOND FLOOR UPSTAIRS RIGHT SIDE HALLWAY**

Suggest elevate arched cased openings  
Decking improvements needed radius at top of stairs  
Ceiling joist needed over stairs to 3<sup>rd</sup> deck fro sheet rocking as needed

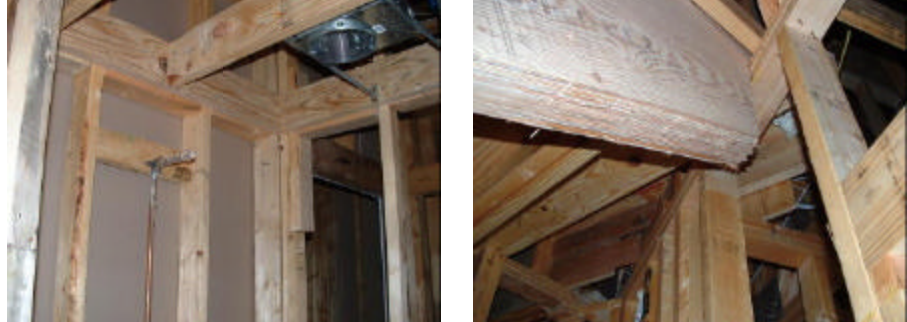
**SECOND FLOOR HALL BATH**

Verify electric location over sink for wall mounted lights  
Protect tub vinyl liner  
Protect toilet PVC  
Suggest elevate ceiling & raise shower head in shower area  
Suggest add supports underneath radius stair trim fro additional support

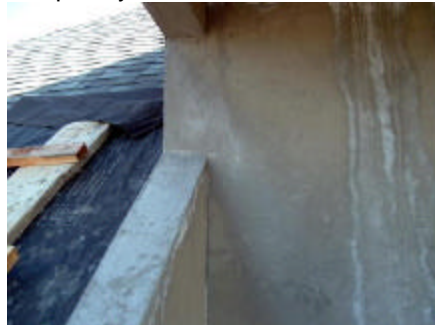
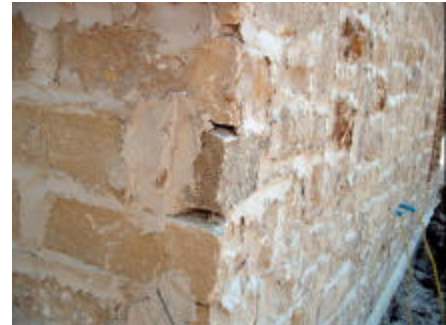
**EXTERIOR WALLS**

Hard coat stucco and stone façade not completely installed at time of inspection. Properly caulk all window frames to brick or stucco as needed and paint all metal lintels over windows/doors as needed. Properly seal all exterior wall board damaged areas as needed. Numerous mortar voids present at scattered locations of exterior façade wall – completely seal voids as needed.

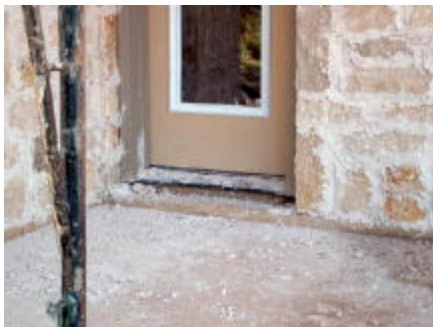
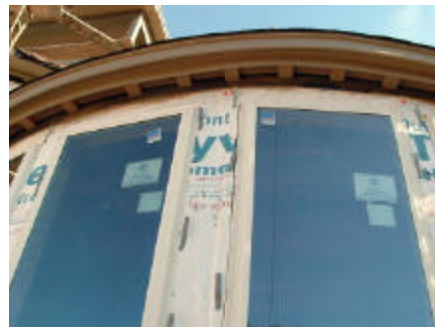
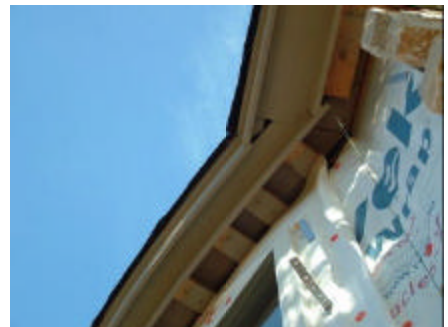
Verify that weep holes are placed approx. 6" – 8" apart at the bottom course of exterior brick/stone façade walls as needed. Install brick supports under all exterior door threshold areas as needed. It is suggested to install peel and stick window flashing to assist in waterproofing of windows. No brick ties were found at the lower brick wall section at the rear of house at patio and master bedroom area – FYI. Repair the soffitt voids at the rear of master bedroom areas – two locations.

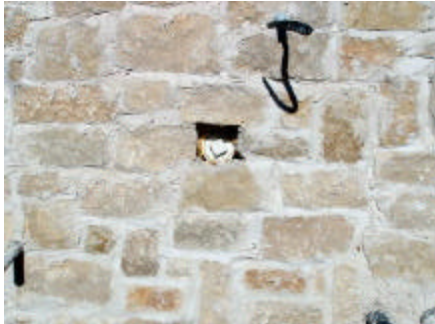
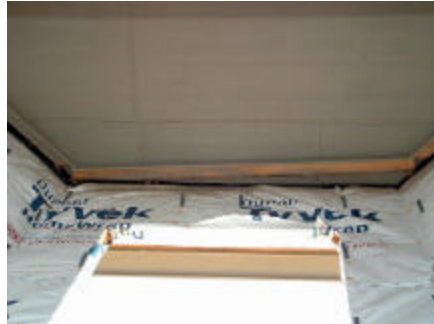
Extend the PVC clean out at the left side of house and seal voids as needed.  
The brick freeze trim at the front entry soffitt area does not run parallel to wall area – repair as needed for proper reveal.

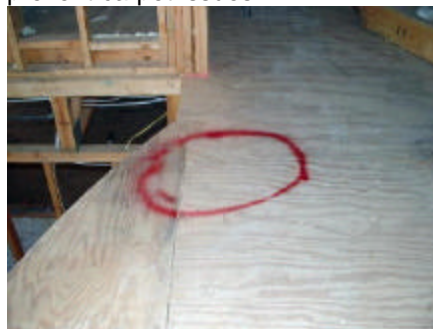
**F. Ceilings & Floors**

Not complete at time of inspection.

Verify that all sub-floor decking has been properly screwed down to prevent nuisance squeaks and all swollen butt joints should be sanded or planed smooth to prevent carpet issues.

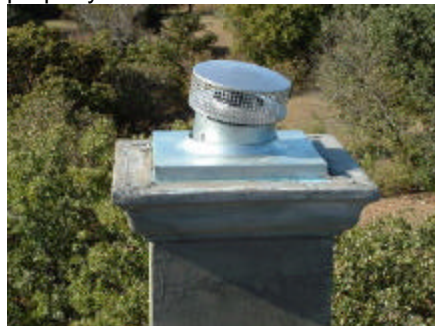
**I. Fireplace/Chimney**

Install rain collar & seal as needed vent cap at rear fireplace, install vent cap properly.

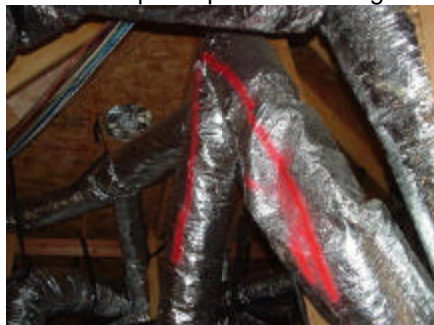
| <input checked="" type="checkbox"/> | <input type="checkbox"/> | <input type="checkbox"/> | <input checked="" type="checkbox"/> | <p><b>C. Ducts and Vents</b><br/> <i>Comments:</i><br/> Reroute/Replace pinched/damaged flex duct 3<sup>rd</sup> floor attic area as needed.</p> |
